FALSE RIVER WATERSHED
INTERIM REPORT ON HCR 168 OF 2011
REGULAR LEGISLATIVE SESSION

Louisiana Department of Natural Resources
and
Louisiana Department of Wildlife and Fisheries

March 2012

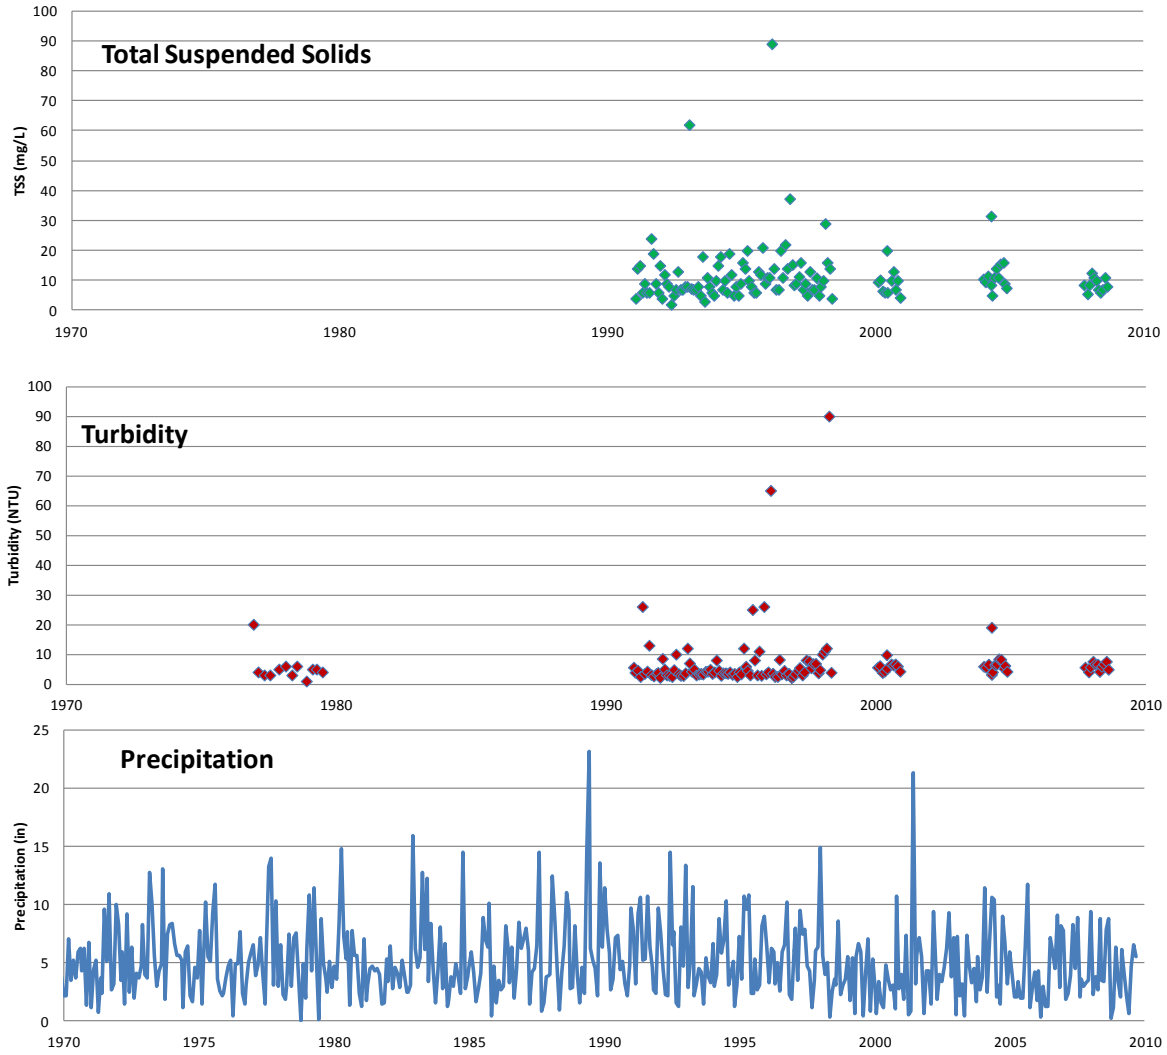
Figure 4: Comparison of precipitation versus TSS and Turbidity in False River (1970 – 2010). (Source: LDEQ Ambient Water Quality Program and National Climatic Data Center Baton Rouge Ryan Airport monthly precipitation values)

The hydraulic characteristics of the M-1 Canal are poorly known and only anecdotal information is available regarding the trapping efficiency of the M-1 Canal Sediment Basin (Table 1 and Figure 6). Information is needed to determine the effectiveness of the modifications to further reduce sedimentation (e.g. siltation and turbidity) from this source. The information needed includes the response of the M-1 Canal drainage network to storm events of different magnitude with respect to stream discharge, flow velocity, water turbidity and total suspended solid load.

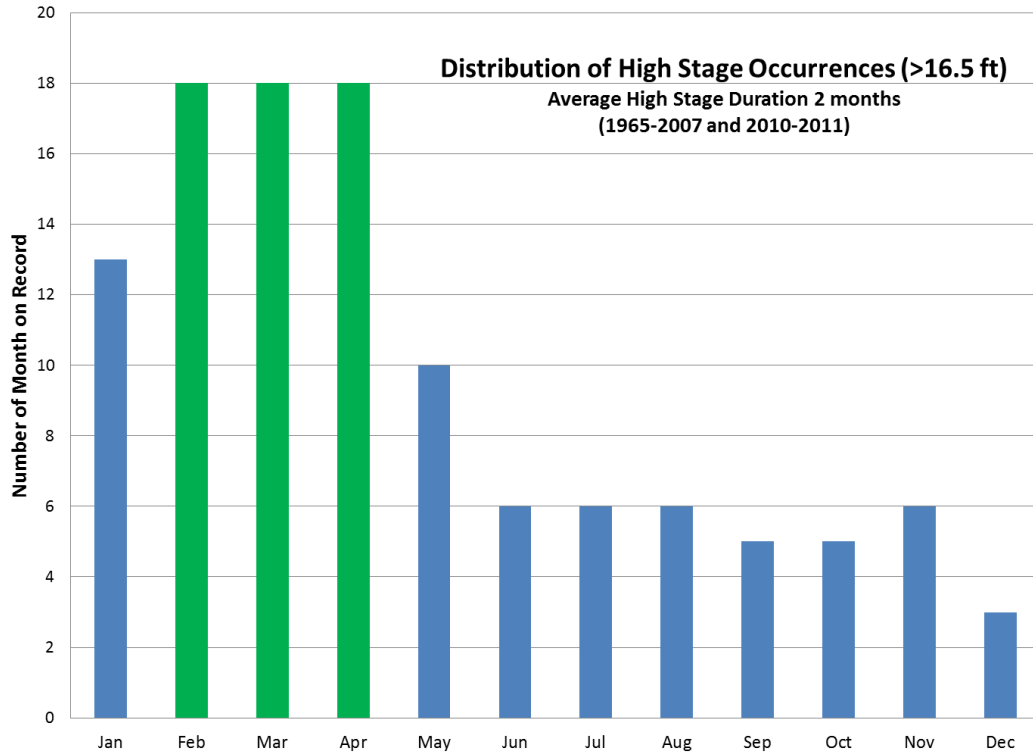
Figure 9: Historical distribution of high lake stages in False River.

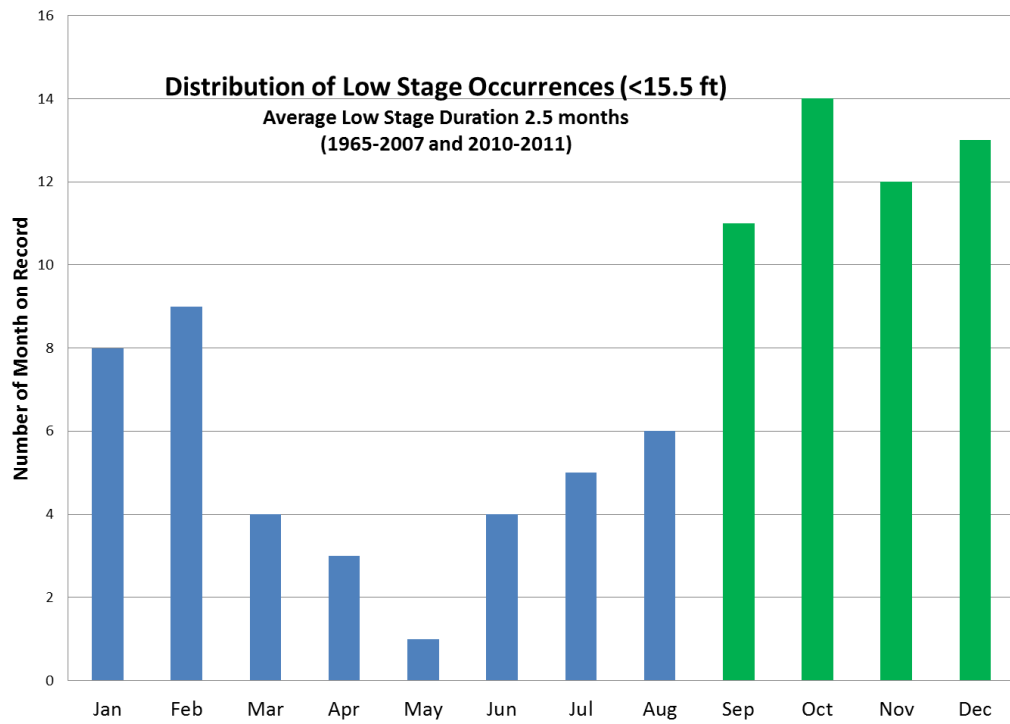
Figure 10: Historical distribution of low lake stages in False River.

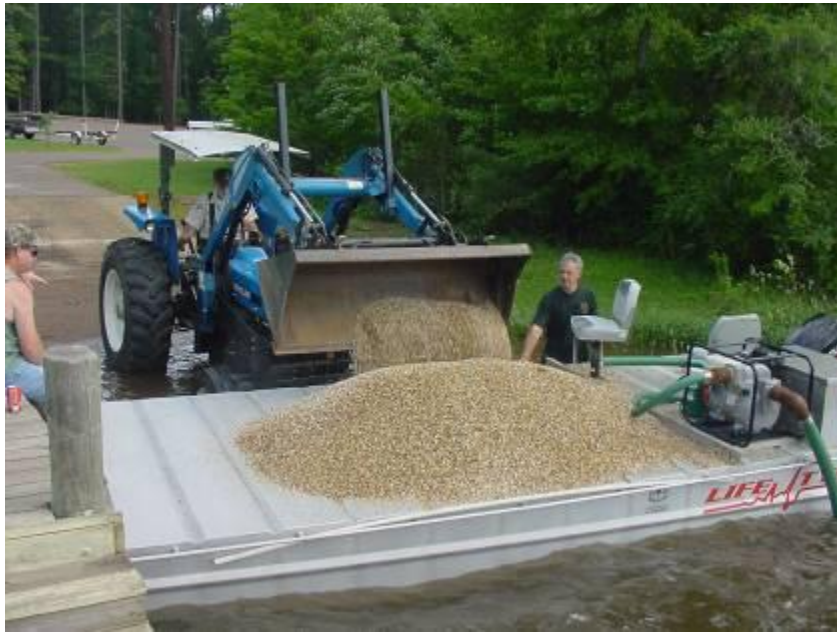
Example of loading out gravel on barge for transport to spawning bed site. Gravel is then washed off the barge with a water pump.

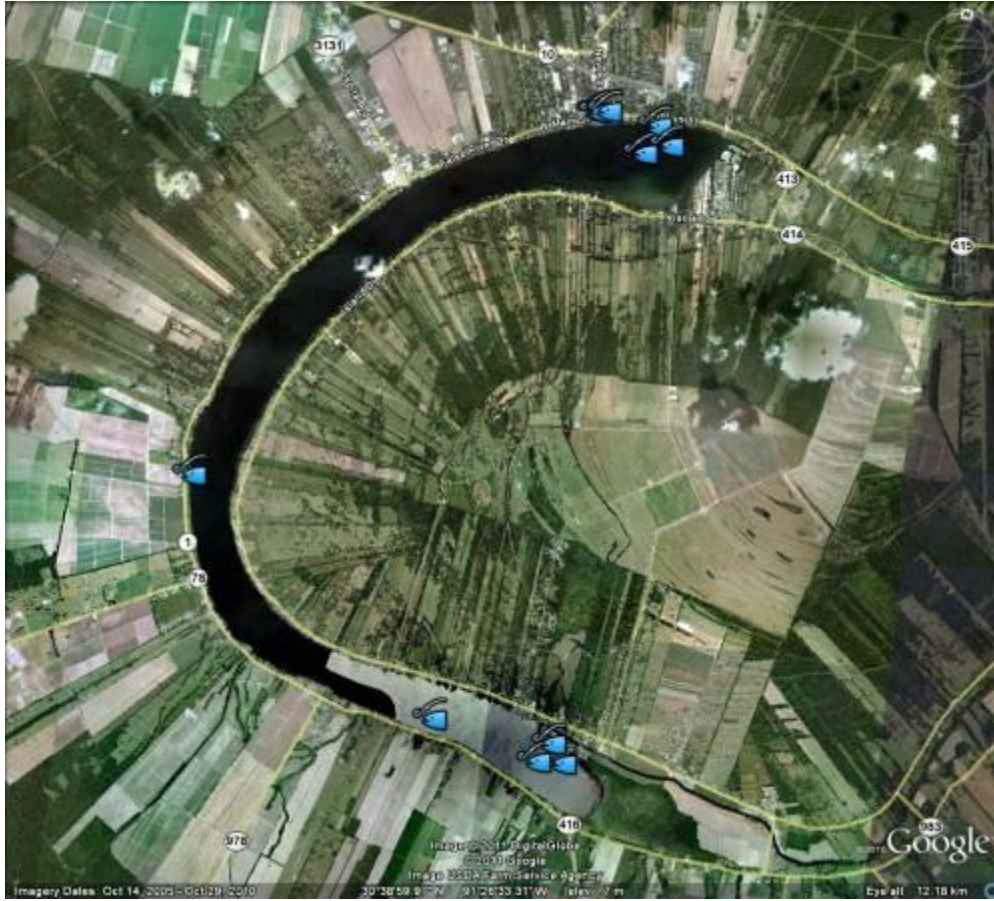
Map

Potential sites for placement of artificial fish attractant structures in False River, LA.
