**MANAGING
FALSE RIVER
WATERSHED
RESOURCES**

An Interim Report to the Louisiana Legislature

February 2018

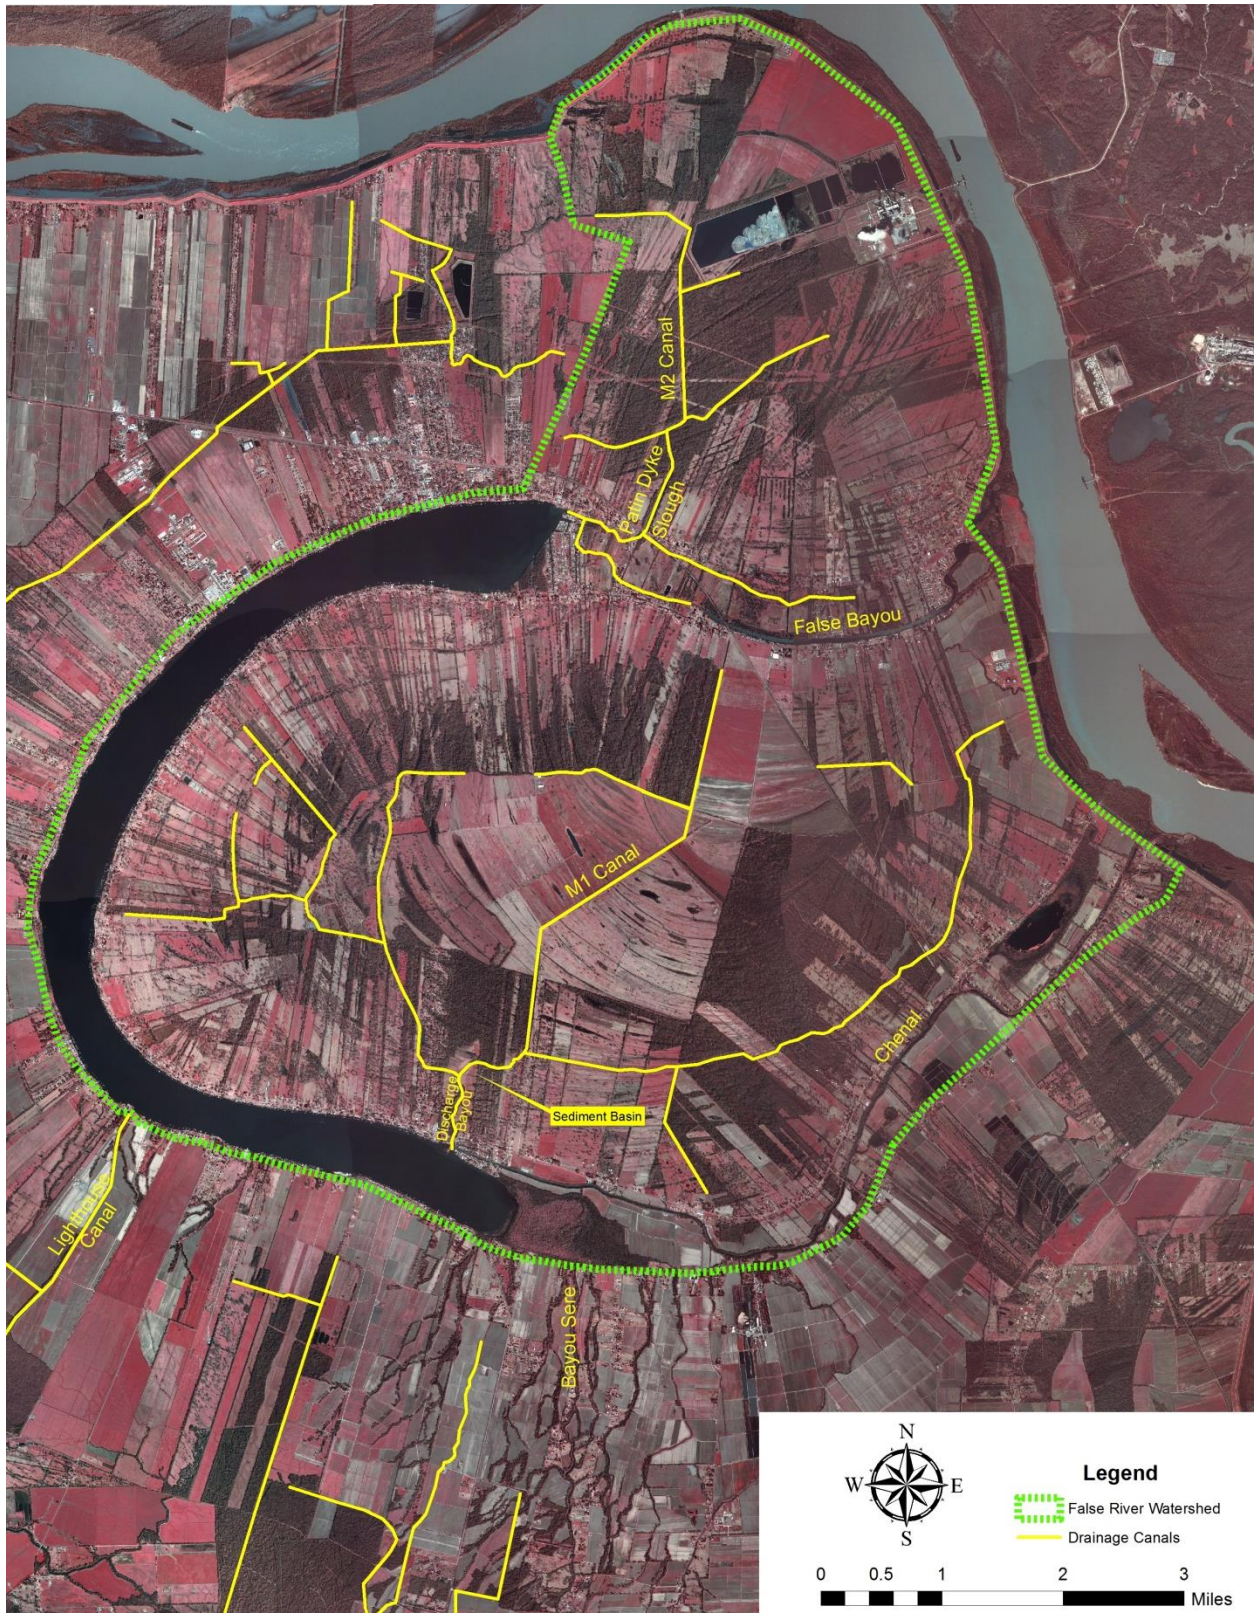
Figure 1: False River Watershed

False River is an abandoned meander of the Mississippi River (Figure 1). The cut-off began prior to 1699, and was well established by 1719. Alterations along this oxbow lake and within this oxbow lake’s watershed have resulted in deterioration of the water quality, aquatic vegetation and fisheries. The extent of the False River watershed is shown on Figure 1.

In 2012, an engineering firm, under contract by the LDNR began collecting hydrologic data along Discharge Bayou, including the M-1 Canal and its tributaries, the Chenal, the M-2 Canal and its tributaries and False Bayou (Figure 1) to assess the hydrologic response of this portion of the watershed to storm events and model the current hydrologic conditions on The Island. The model was used to evaluate potential hydromodifications along the drainage canals and bayous to delay peak flow and increase storage capacity. A second phase of the data collection and modeling including the M-2 Canal and its tributaries and False Bayou began in 2015 and is ongoing with post construction monitoring. The draft report prepared by the engineering firm is included in Appendix A.

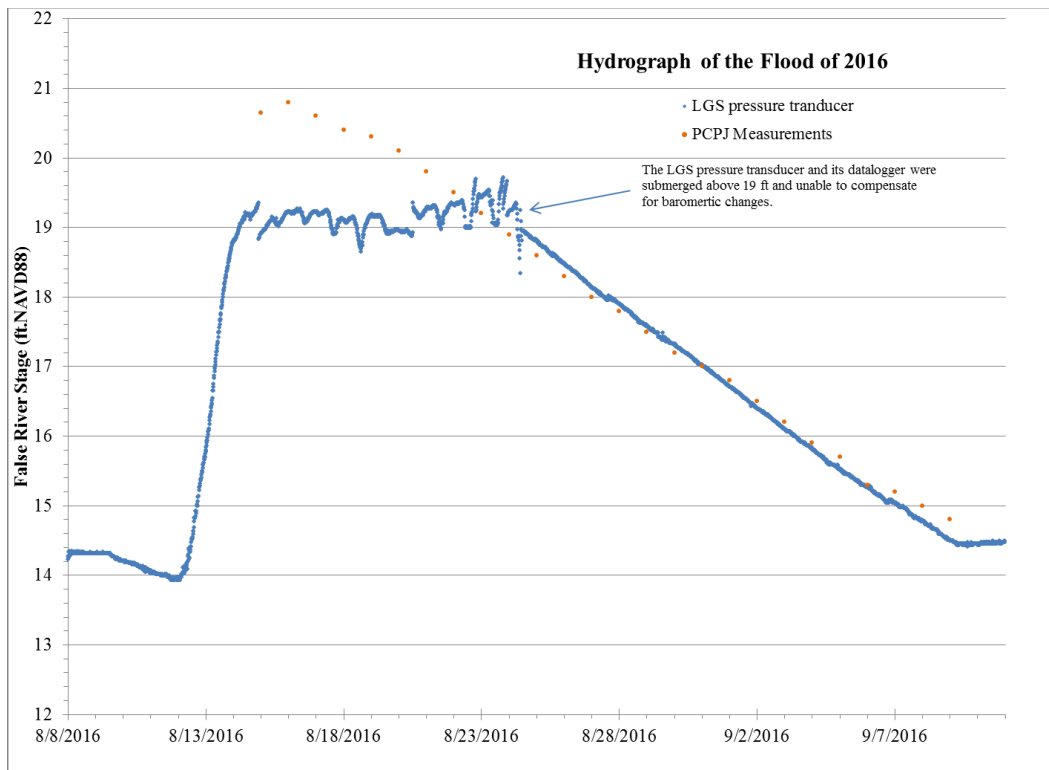
Figure 6: Hydrograph of the Flood of August 2016.

In August 2016, Southeastern Louisiana experienced a storm event that precipitated within 24-hours span up to 32 inches of rain in places. For two days prior to the storm the PCPJ lowered the lake level in anticipation of the storm (Figure 6). The event showed lake levels rising from a stage of 15.2 ft NGVD (14.0 ft NAVD) to a crest of 22 feet NGVD (20.8 ft NAVD) in the span of five days and it required 24 days for the lake to return to pool stage (16 ft NGVD) with all three gates open and discharge occurring from the Bayou Sere outfall as well (occurs naturally above approximately 16.5 ft NGVD).

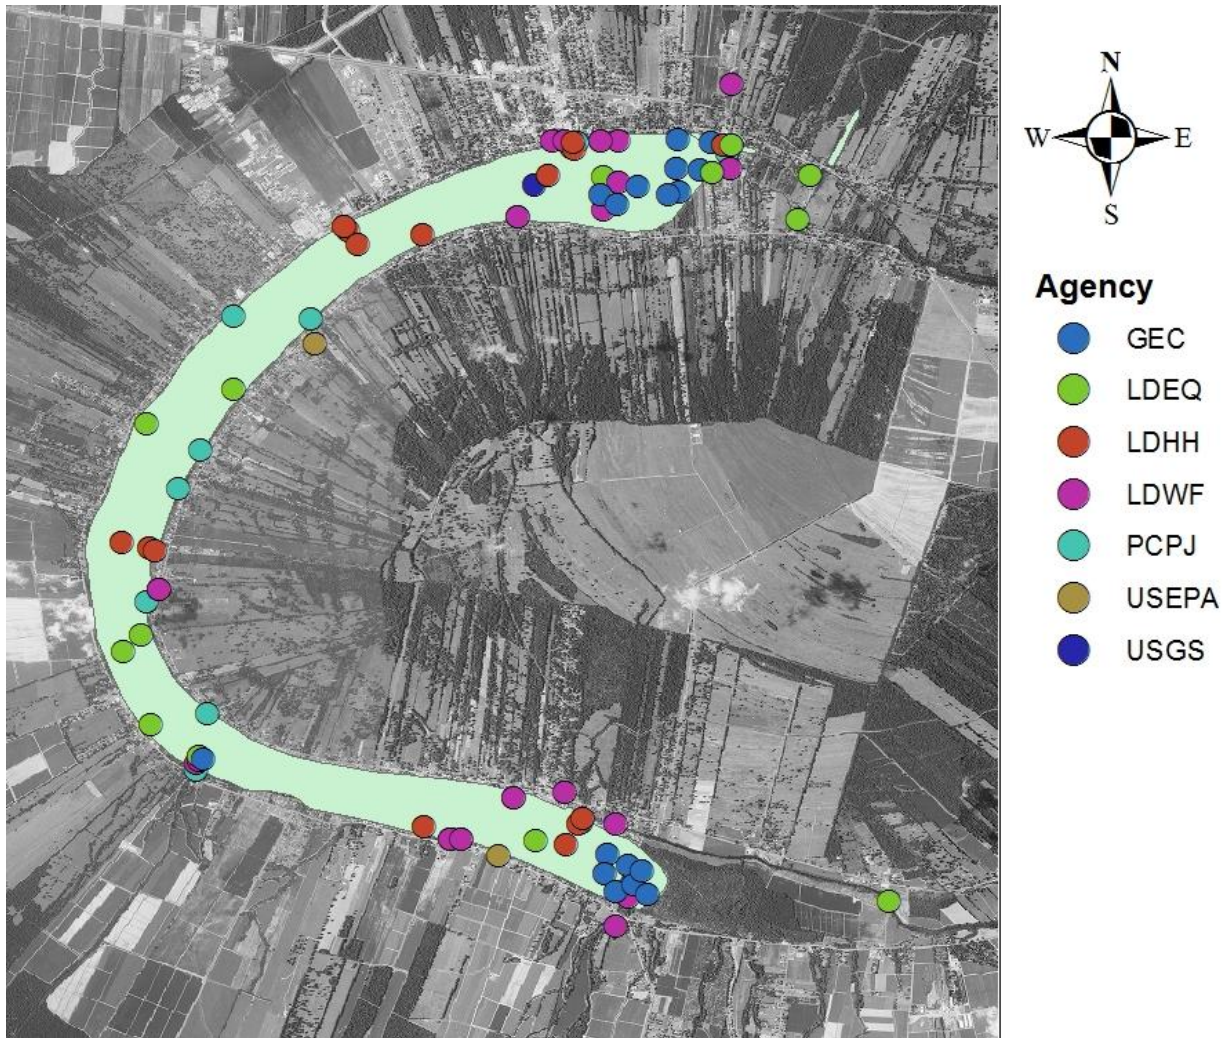
Figure 7: False River sampling and gaging locations

Water quality samples have been collected by various state and federal agencies or their contractor since November 18, 1963. There are over 90 locations within the watershed where water quality and sediment samples were collected (Figure 7). Over 27,000 readings and/or analyses were performed on water samples, and over 620 on sediment samples. In addition, over 44 fish tissue analyses are also available. This data was compiled by the LDNR into a database and used to prepare this report. Water sampling is ongoing by the LDEQ as part of routine ambient monitoring and by the engineering firm as part of the Nitrogen Impact Mitigation Project.

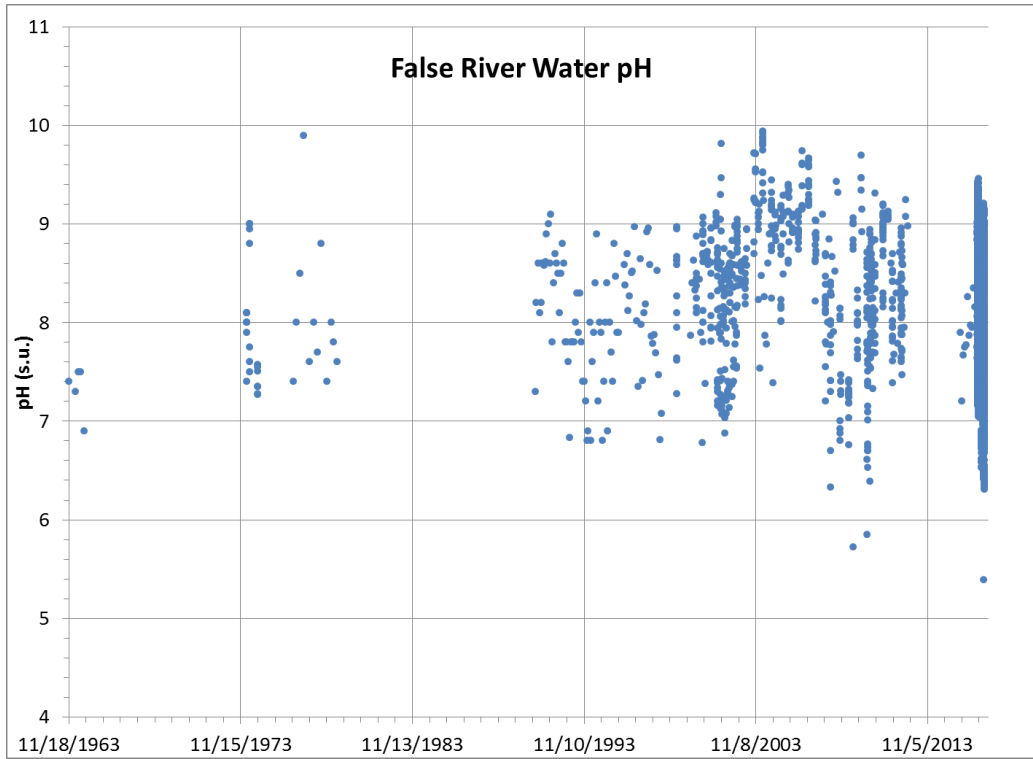
Figure 8: False River pH readings

The data collected suggests that the pH of False River is showing to be stable over the last 50 years (Figure 8), although in the recent past several values have shown to be low (<6 s.u.). LDEQ's numerical criteria for pH in False River is between 6.0-8.5 s.u. It is expected that the observed seasonal variability in pH values is due to the similar increase in water temperature and nutrient loading of the lake.

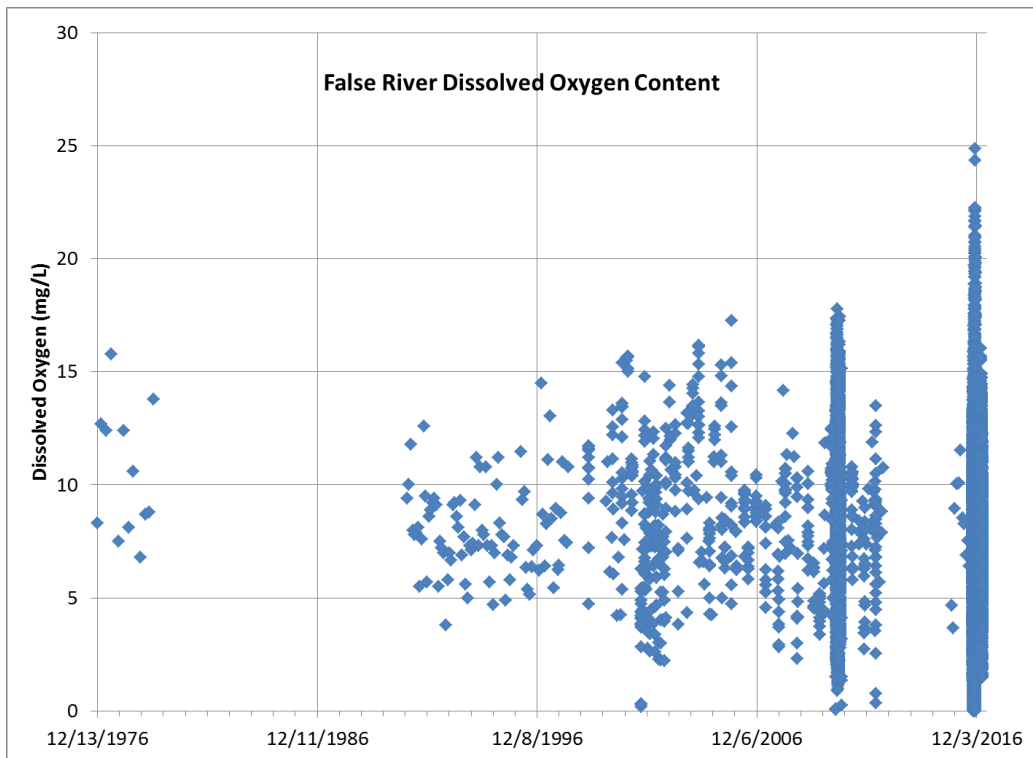
Figure 9: False River dissolved oxygen concentrations

The data collected suggests that dissolved oxygen concentrations in False River have been declining over the record period (Figure 9), although the highest recorded values were observed during November 2016, which coincide with the lowest lake levels recorded during the Fall drawdown that year (Figure 10). This overall decline can be partially attributed to poor water clarity, resulting in less sunlight reaching deeper into the lake's water. Sunlight fosters the growth of aquatic vegetation, and, therefore, photosynthesis and oxygen production. Without the presence of continuous water flow, False River is subject to annual stratification, a condition common to aquatic ecosystems. During the warm months of the year, stratification forms due to the effects of sunlight. The upper layer is warmer and less dense. The thickness of this upper layer is directly related to water clarity. In clear water, sunlight penetrates more deeply than in turbid water. Because sunlight is a requirement for oxygen production through photosynthesis, this upper layer is the region of highest dissolved oxygen. Water below the upper layer receives little sunlight, and, therefore, is colder and denser. This deeper layer has no incoming oxygen, and typically has very low dissolved oxygen. False River stratifies annually, and develops a 5 to 6-foot upper layer. Because the average depth of False River is 21 feet, aquatic life that requires oxygen is limited to the relatively small portion of the waterbody during the warm months of the year. LDEQ's numerical criteria for dissolved oxygen in False River is 3.3 mg/L (April-Sept.) and 5.0 mg/L (Oct.-Mar.). False River values seasonally dip below those criteria.

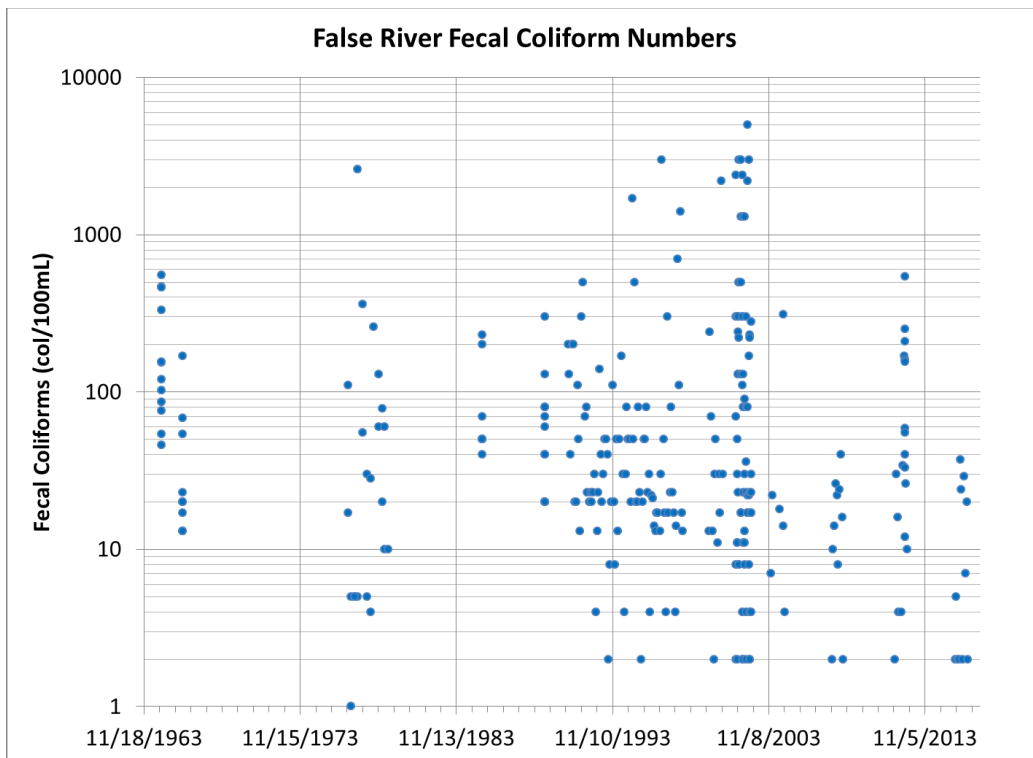
Figure 11: False River fecal coliform concentration

In the late 1990s and early 2000s, the PCPJ investigated the source of elevated fecal coliform counts measured in the lake's water (Figure 11). The PCPJ and other stakeholders remedied the sources identified by repairing and extending sewers. As shown on Figure 11, fecal coliform exceedences (primary standard: >400 col/100 mL and secondary standard: >2,000 col/100mL) were more common prior to 2004, and have not been observed since. Overall, fecal coliform counts in lake water have been declining during the period of record.

There are numerous camps and residences along False River serviced by individual sewerage system. In the late 1990s and early 2000s, the PCPJ investigated the source of elevated fecal coliform counts measured in the lake's water (Figure 11). The PCPJ and other stakeholders remedied the sources identified by repairing and extending sewers. In addition, the LDH is requiring the update of individual waste treatment systems when a property transfer occurs. Recently, the PCPJ has made an application to LDH in order to finance the expansion of sewer service around the lake.

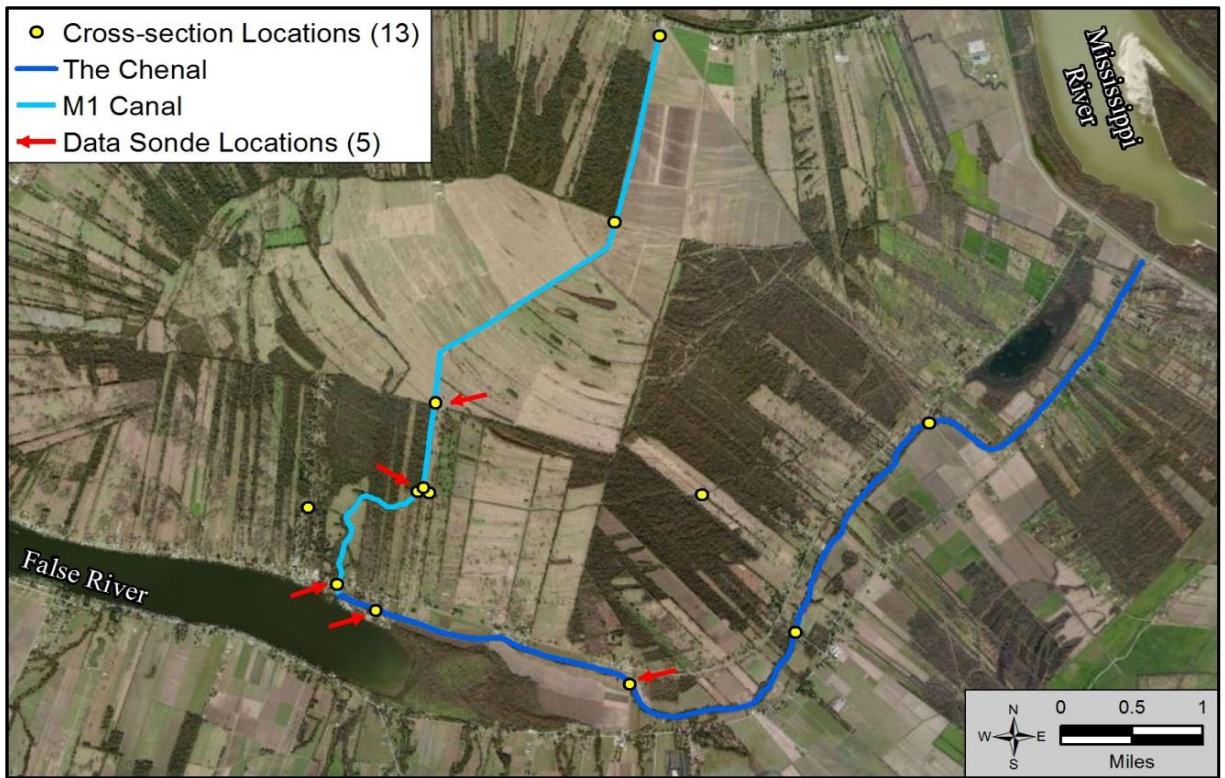
Figure 17: Location of data sondes on The Island drainage network

Funded first by the LDNR and then consequently by Louisiana Generating LLC, in late 2012, Fenstermaker & Associates LLC began an hydrologic study of the watershed. First, the consultants placed data gathering equipment in the M-1 Canal and the Chenal to determine the hydrology of this portion of the watershed and the current level of sediment flux into the South Flats (Figure 17). A local surveyor surveyed the channels profile and the data sonde housings. Six months of continuous data was collected, and used to model the hydrologic conditions on The Island. Data was continuously being downloaded and processed (Figures 18 and 19). Local residents assisted Fenstermaker & Associates LLC staff, by collecting time sensitive water

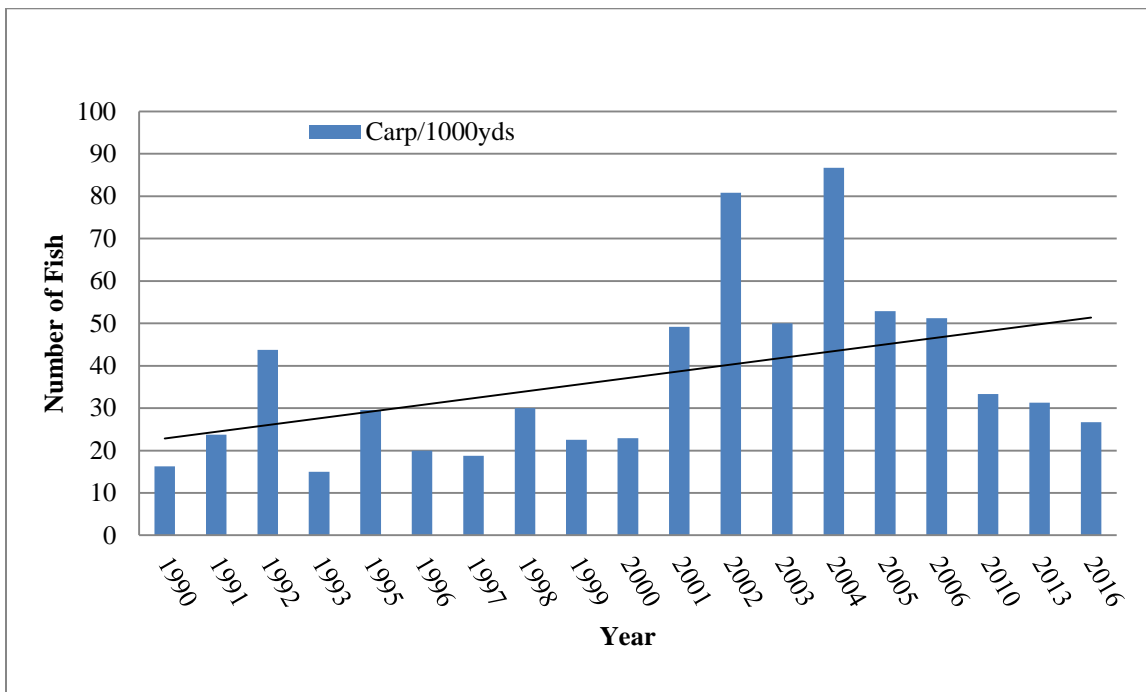
Figure 25: Common carp CPUE from gillnet samples on FR (1990 to 2016)

Due to habitat degradation that has occurred over the years, and the increase in rough fish, particularly carp species (Figure 25), there is a need for control of these invasive fish populations. Asian carp (i.e., common carp) are present in False River. Gillnet data depicted in Figure 25 has shown an increase in carp catches, especially since 2000 [reported in catch-per-unit-effort (CPUE)]. This is probably due to the increase of soft sediments, and the commercial netting ban that was in place until 2012.

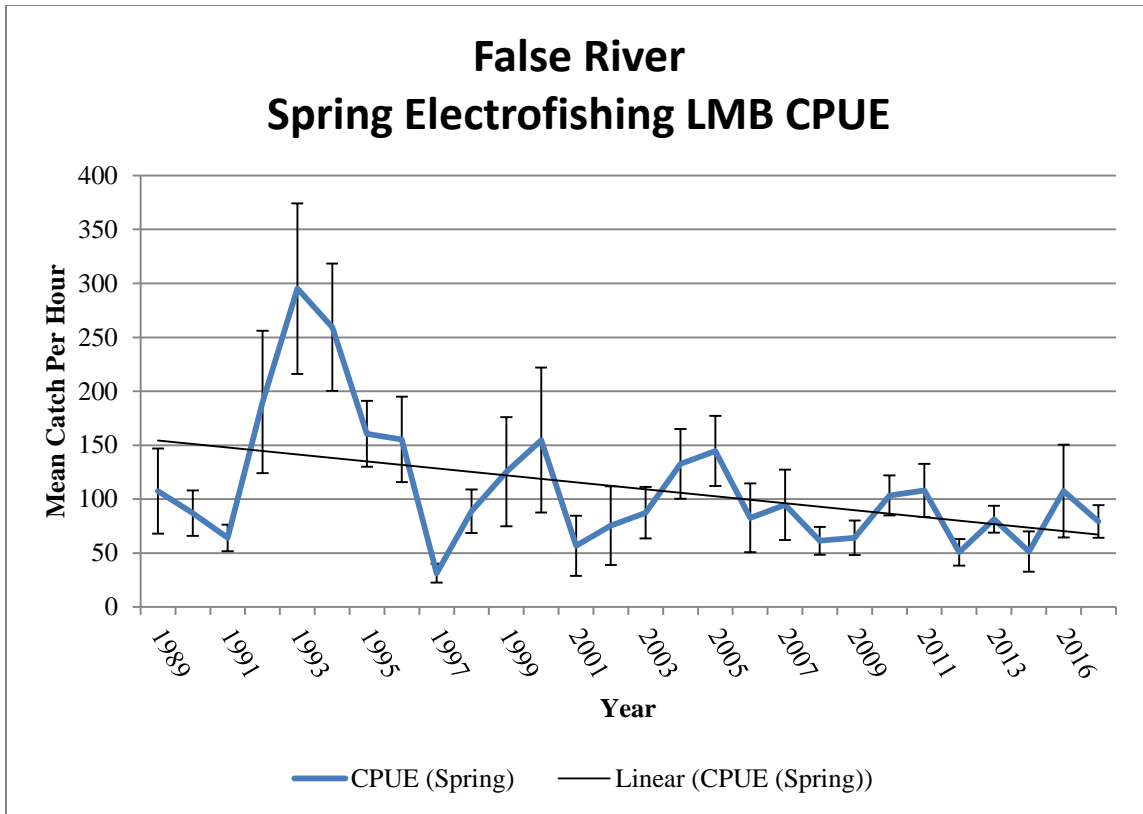
Figure 26: CPUE values for largemouth bass on FR (1989 to 2017)

Due to the overall declining bass population, trophy lake status for False River was rescinded in 1998. This decline followed the completion of the Bayou Grosse Tete Watershed Project. The additional drainage lead to heavy sedimentation on the north and south ends of the lake. Consequently, this resulted in loss of spawning habitat, and virtual elimination of submersed aquatic vegetation. Since 2000, total spring electrofishing catch rate has fluctuated widely between 50 and 154 bass per hour (Figure 26). Work done to reduce erosion in the M-1 Canal in 2005 and clean out the sediment trap in 2006 was followed by a rise in quality size fish. These higher numbers indicate that more habitat is available for successful spawns. Contrary to other fish populations in the region, the fish populations of False River did not suffer from hypoxia-induced fish kills following Hurricanes Katrina (2005) and Gustav (2008).

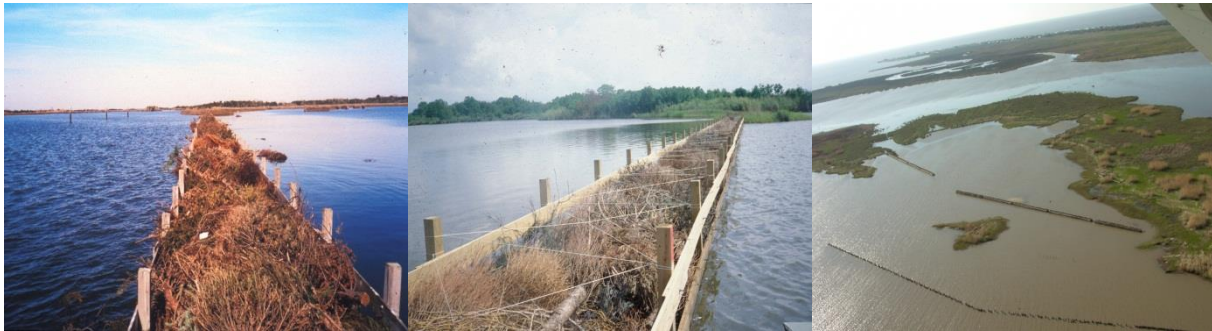
Figure 34: Examples of shoreline mitigation treatments

Any shoreline treatment that mimics the lake's natural shoreline and provide edge habitat would be a huge advantage over vertical bulkheads. There are several methods to "harden" a shoreline while having it appear to be natural. This method uses gentle slopes and vegetation to dissipate wave energy.

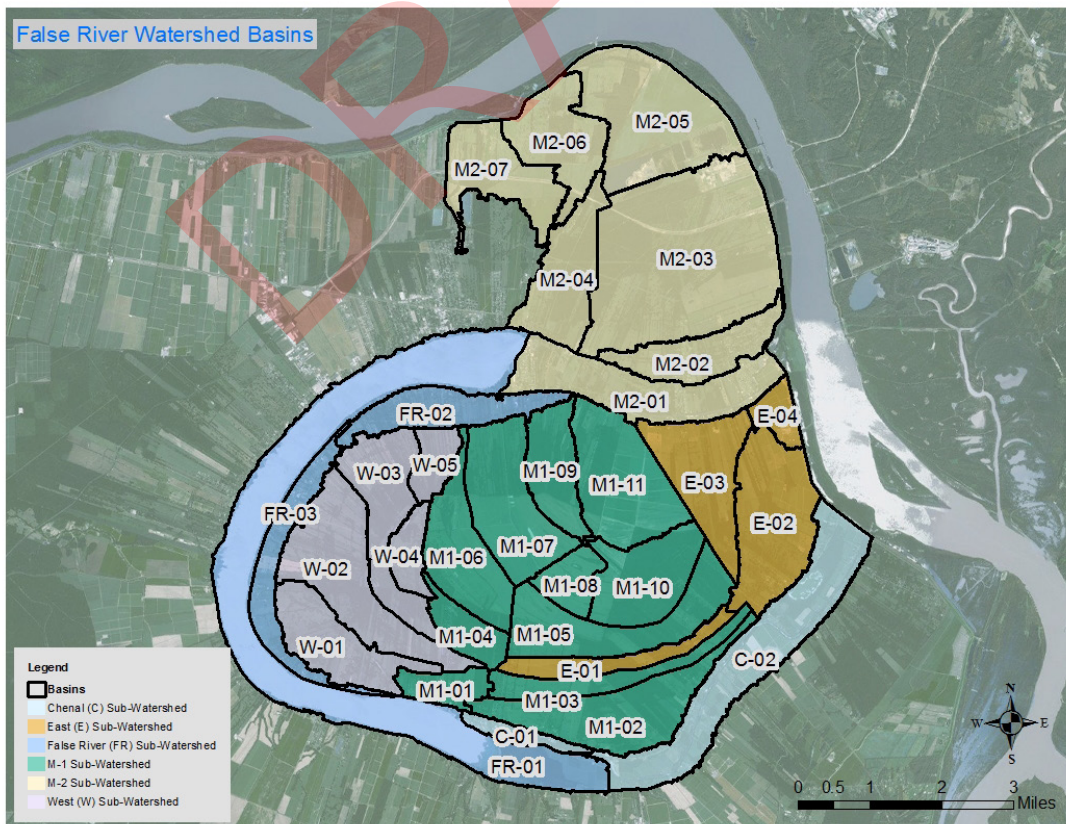
Figure 2 - False River Watershed Basins

Sub-watershed	Area (acres)	Runoff Volume (acre-ft)
Chenal	2,248	622
East	3,415	1,008
False River	5,879	1,793
M-1	9,886	2,920
M-2	10,803	3,292
West	4,324	1,275

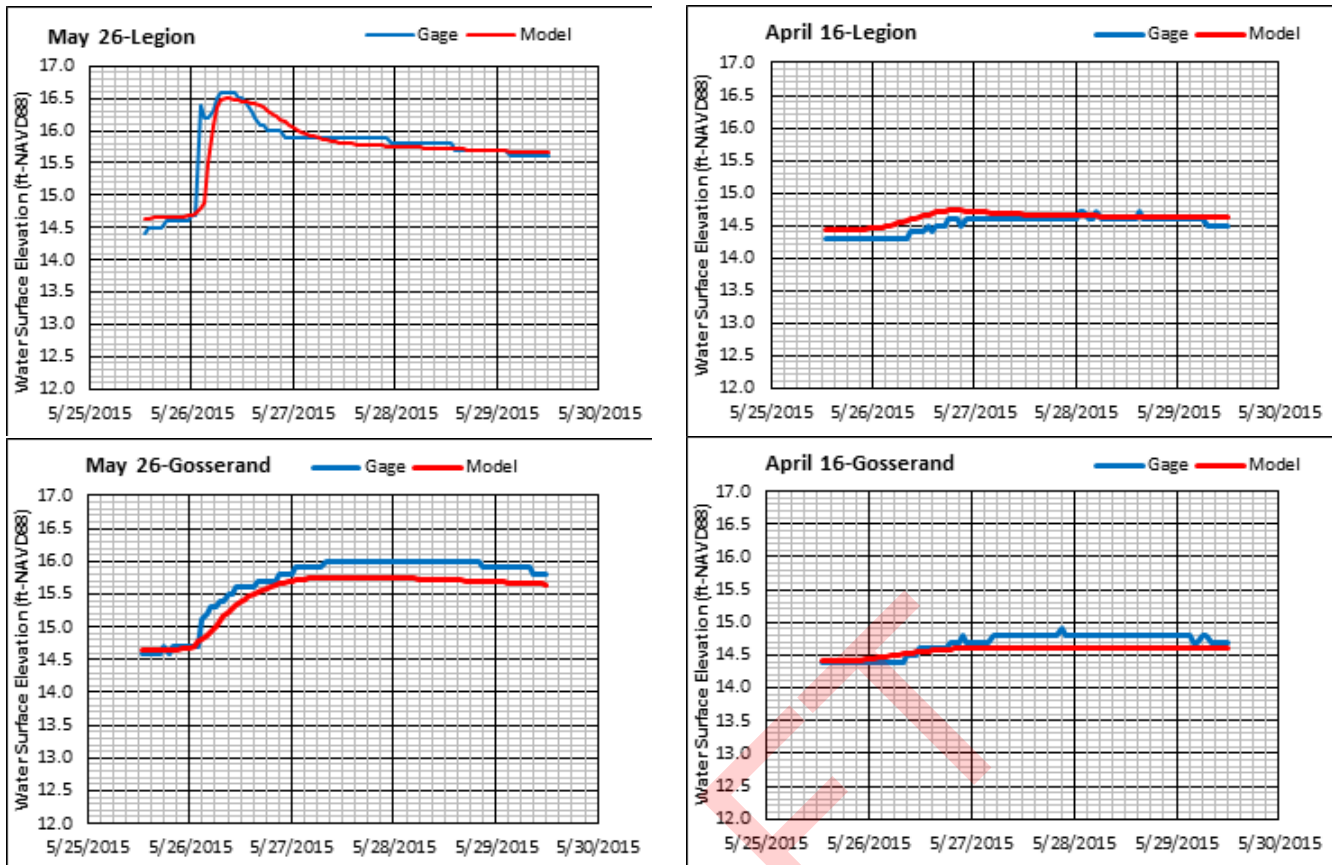
Figure 12 - Modeled Water Level Comparisons

The HEC-RAS hydraulic models were developed using survey data, field visits, and water levels collected as a part of a project-specific monitoring program. These

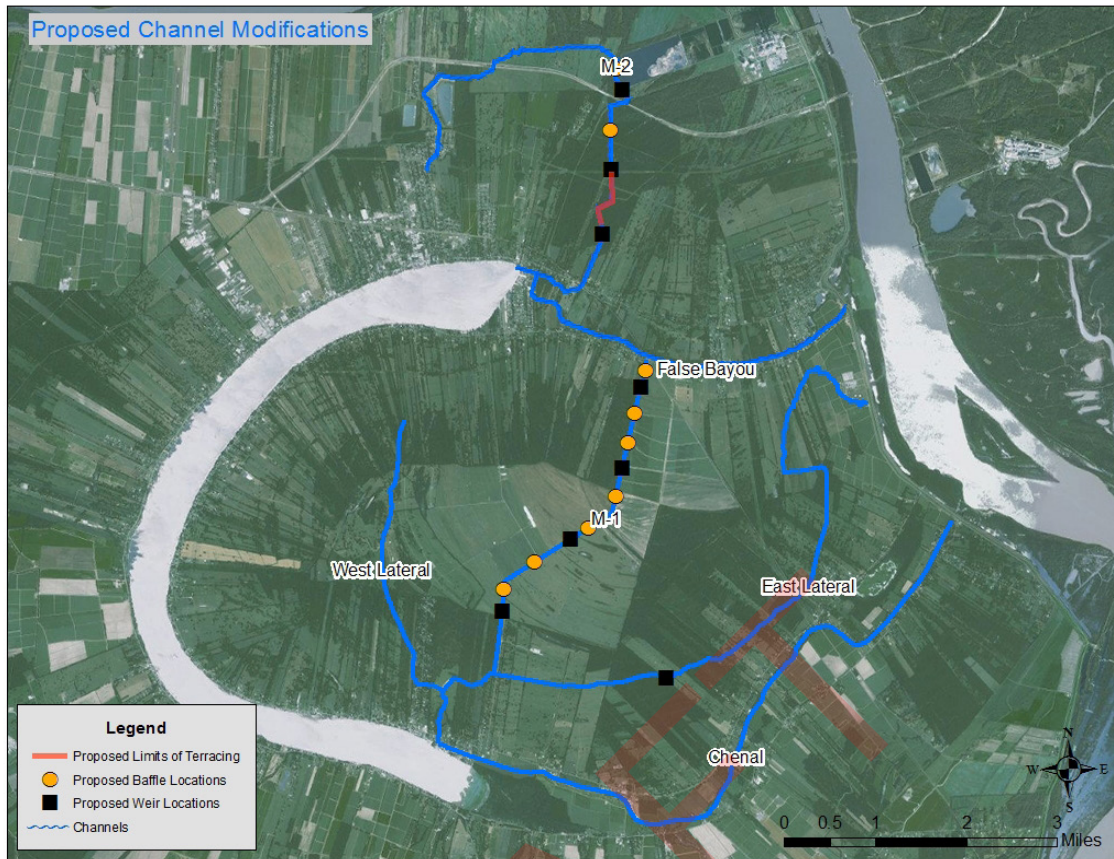
Figure 20 - Recommended Channel Modifications

Riparian buffers are highly recommended along the overbanks of the channel to act as filters to remove pollutants, nitrogen, and sediments from stormwater runoff entering False River. The majority of plant materials for the riparian buffers should consist of existing, naturally generated vegetation suitable for the soils and hydrology of the site. The USDA NRCS provides criteria for plant

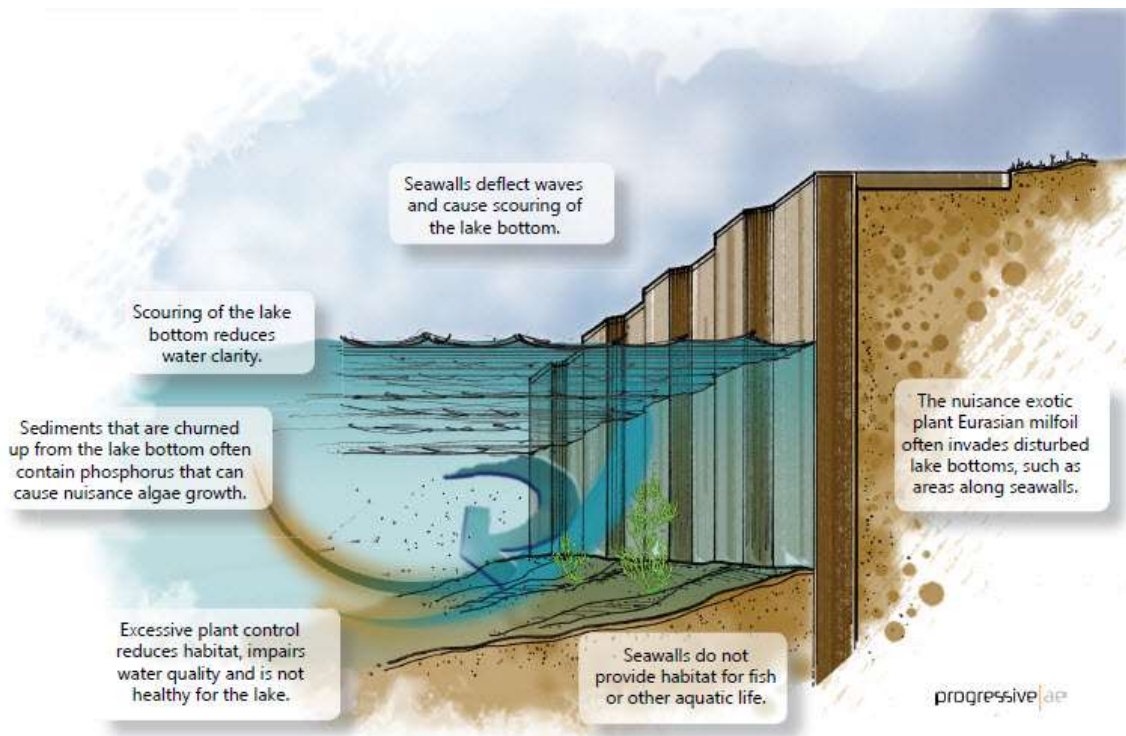
Figure 1: Hardened Shorelines
(Source: progressiveae.com)

False River, like any lake, is subject to shoreline erosion from wind-driven waves and wake resulting from recreational motor boating. Property owners look for ways to control shoreline erosion when it becomes a problem. The most common hard structures on False River are bulkheads (shore anchored, vertical barriers) and seawalls (stronger cast-in-place concrete, stone or timber high-energy structures). These hard structures can often cause shorelines to be less stable than those protected by natural landscaping, because they do not allow for absorption of the energy that waves bring in. Waves hit the hard structures, and the energy is deflected (Fig. 1). This energy then (1) scours the lake bottom and causes erosion at the base of the wall resulting in increased turbidity of the water, and (2) is deflected to neighboring property causing further erosion.

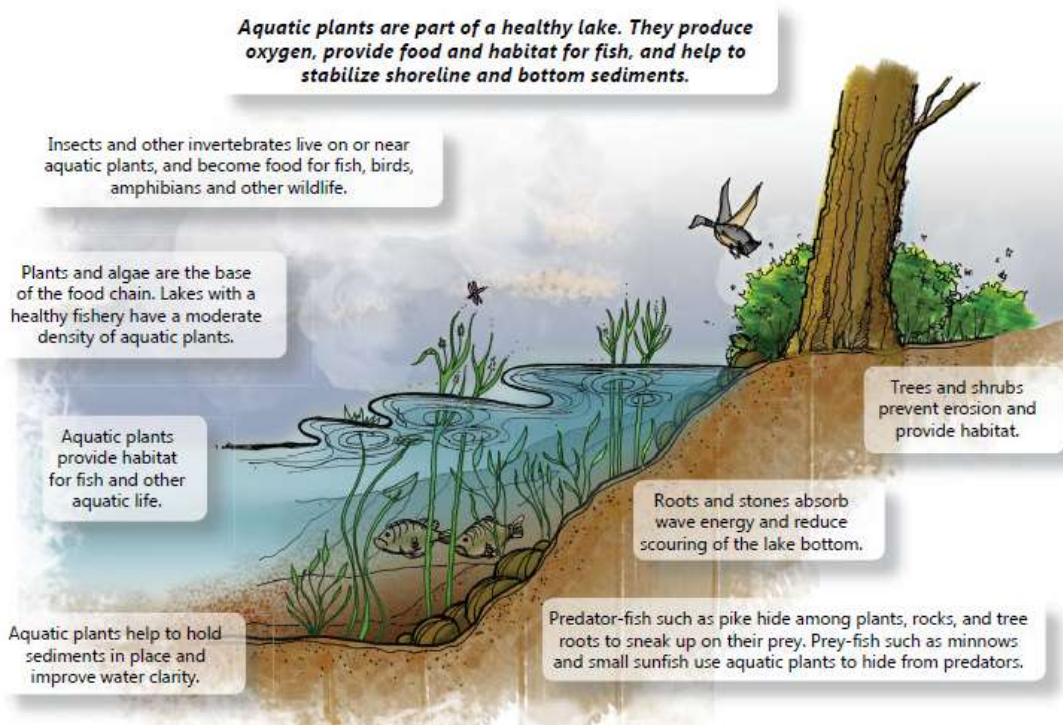
Figure 2: Natural Shoreline
(Source: progressiveae.com)

Natural shorelines (Fig. 2) help to sustain near-shore habitat essential to fisheries. In addition to critical habitat, natural shorelines create a buffer providing numerous water quality benefits, such as filtering stormwater. **Restoring a Natural Waterfront** on False River provides an essential element to restore an aesthetic character to the lake's waterfront using natural shoreline plants (e.g. Baldcypress, shoreline emergent grasses, etc.) and to decrease erosion by attenuating wave deflection.

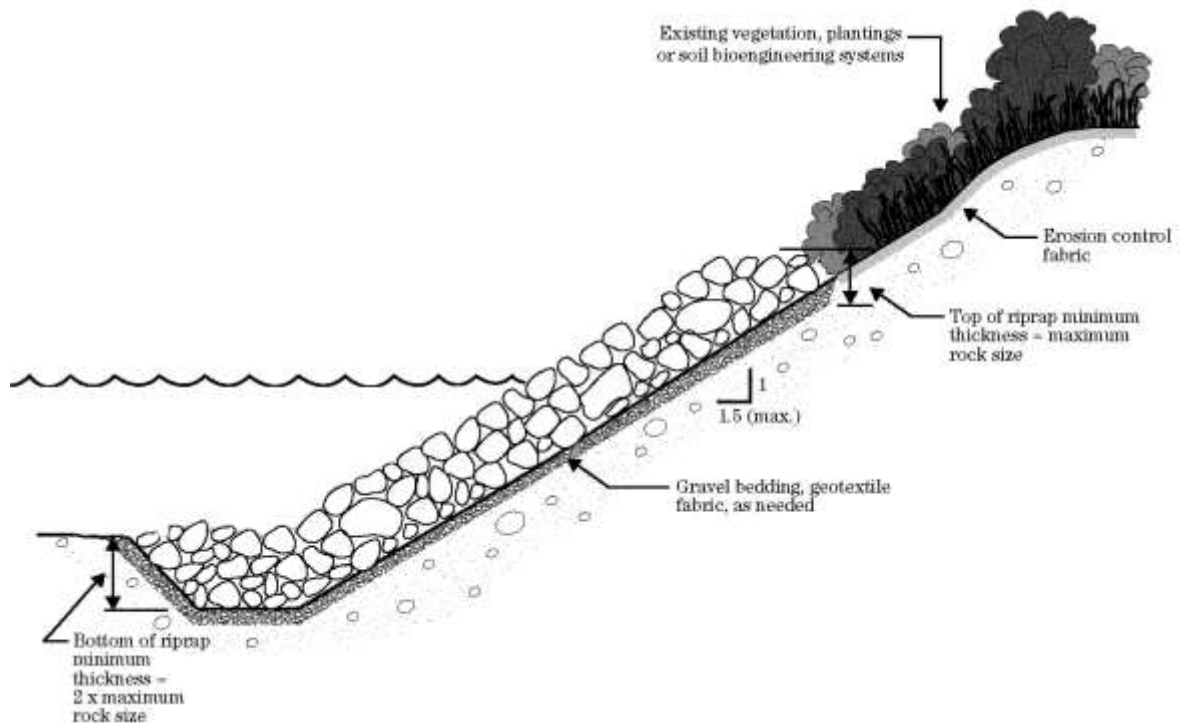
Figure 4: Rock
Revetment
(Source: USDA-
NRCS)

For shoreline where excessive erosion is observed, and natural and bioengineered shoreline may not be adequate, the placement of a **rock revetment** (Fig. 4) may be an appropriate alternative. Although not aesthetically as pleasing as a natural shoreline, it does provide erosion control without causing excessive wave deflection.

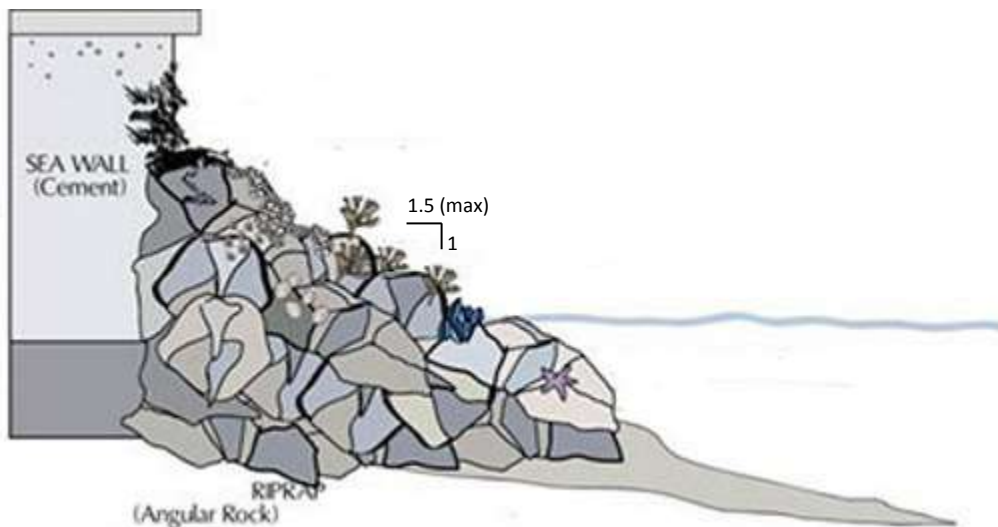
Figure 5: Modified Seawall
(Source: Archipelago Marine Research Ltd.)

An inexpensive manner to modify existing hard structures to attenuate the negative effect of wave deflection from a pre-existing bulkhead or seawall can be achieved by placing rock or rip rap (>6" diameter) in front of the wall. This will decrease scouring, attenuate wave deflection and result in better water quality.

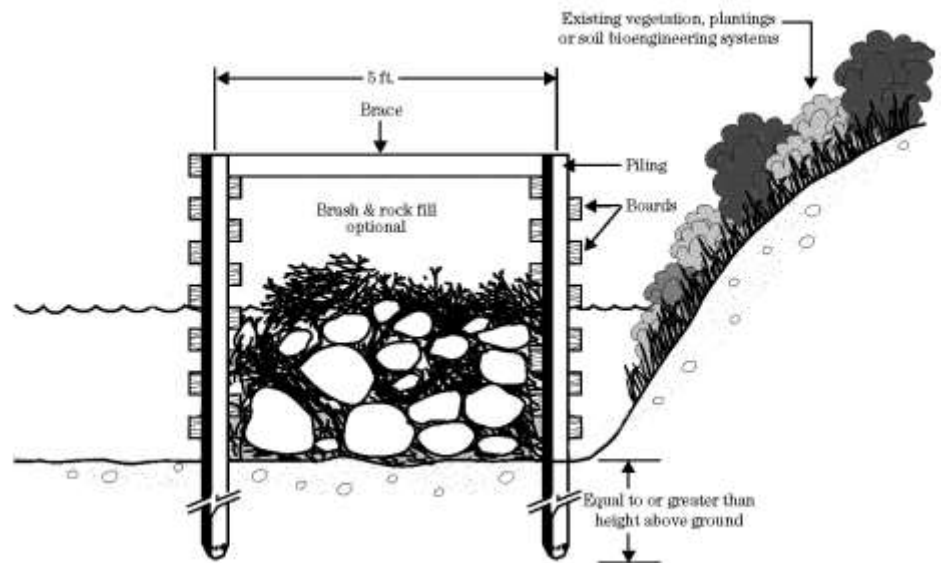
Figure 6: Debris Fence (or Christmas Tree Fence)
(Source: USDA-NRCS)

Another inexpensive shoreline modification commonly used to attenuate incoming waves energy is the installation 10-15 yards in front of hard structures or natural shoreline of a **Debris Fence** (Fig. 6).
